## Passive solar design Looe Junior and Infant School

ENERGY EFFICIENCY

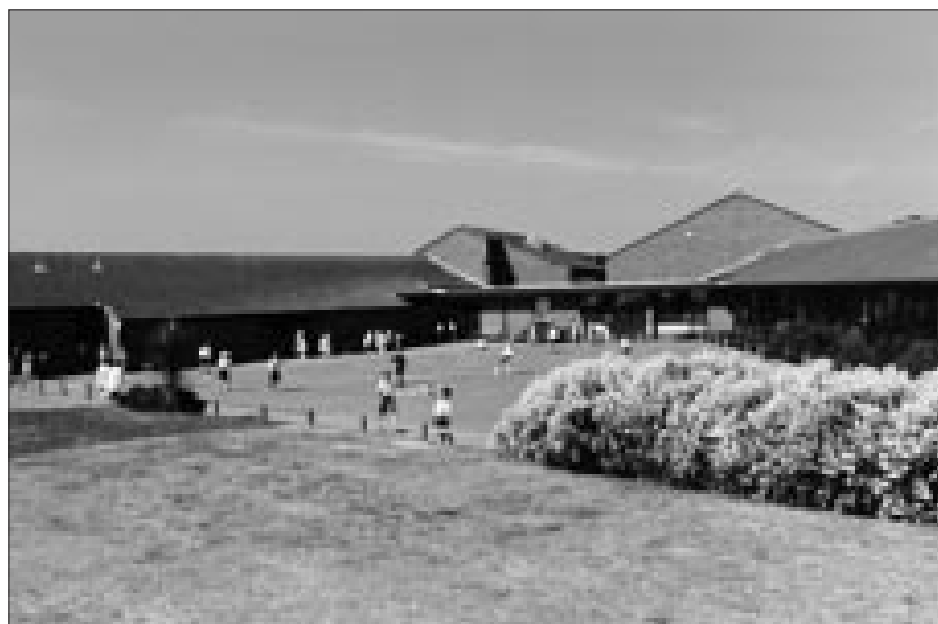
View from east: splay of infant and junior classrooms creates shelter for playground. North elevations only have small windows

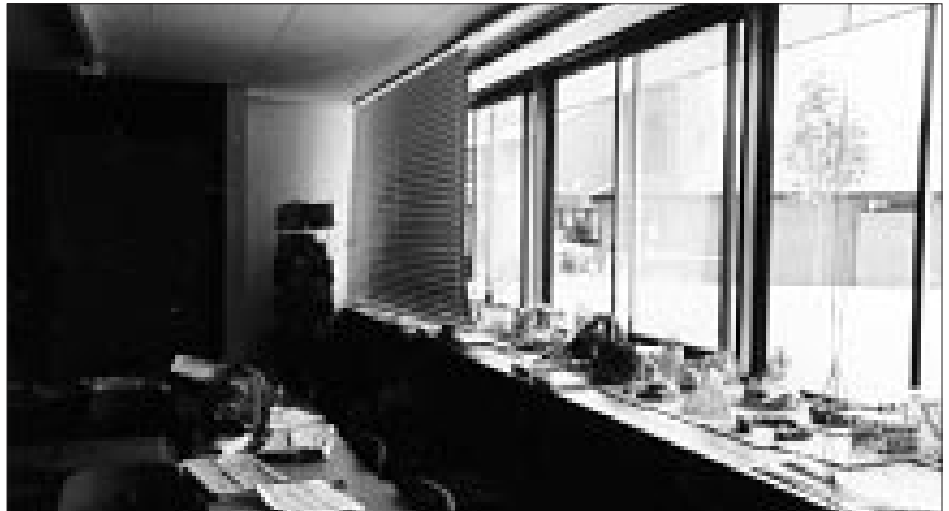
*Venetian blinds control glare in spring and autumn and are positioned to allow sunshine onto the workbench, but can interfere with material on top of it*

To control solar gains through the large areas of glazing in the classrooms, attention has been given to the form and choice of materials used in these areas. Roof eaves have a 750 mm overhang and there are internal venetian blinds to control the solar gains through the large south facing glazing.

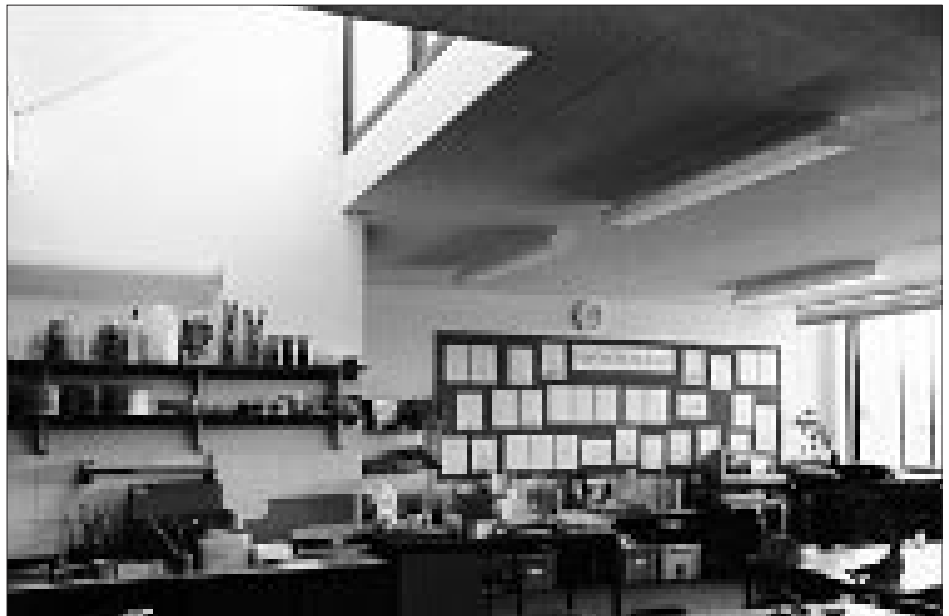
*Infant classroom: the rooflights bringing light to the rear of the rooms were appreciated*

In anticipation of reduced daylight, double glazed south facing rooflights were provided. Those over the workspaces of the juniors provided daylight factors of 10 to 20% and glare and excess solar gains sometimes resulted. Those over the infants' classrooms made surprisingly little difference to daylight factors when measured on an overcast day, although it was observed that they do help light the rear of the room at brighter times. They were also appreciated for giving character to the room by breaking up the plane of the ceiling.

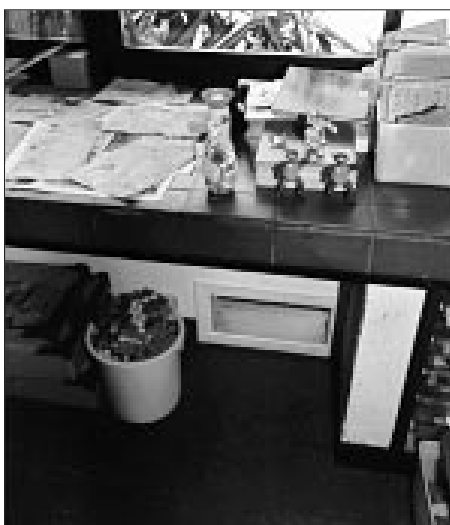
*The Trombe bench has grilles underneath it and in the worktop along the window to allow air to circulate up the cavity. Display material needs to be kept clear of the grilles*

To the outside observer the walls are a completely glazed facade, but internally only 60% of the glazing is visible from the classroom, the rest being Trombe bench. These work surfaces, in the form of tiled concrete worktops and concrete block walls to support it, behind the windows, have several purposes. Acting as mini Trombe walls, they absorb and store solar gains; function as a workbench; and isolate the pupils from the large area of glazing. The glazed cavity between the Trombe bench and the external glazing and ventilation pathways created by the bench were included to promote the circulation of warm air by natural convection currents.

The thermally massive Trombe bench is the only non-standard construction in the building and is constructed from blockwork with a tile-covered concrete slab forming the bench.

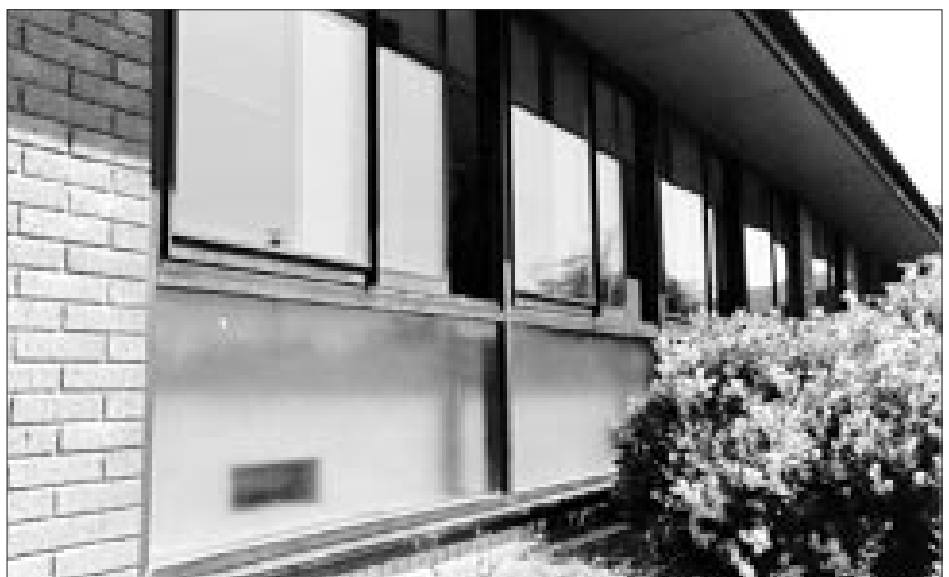
*South elevation of a classroom showing wide roof overhang and continuous windows with Trombe wall below. Planting is growing up and will result in reduced solar gain*

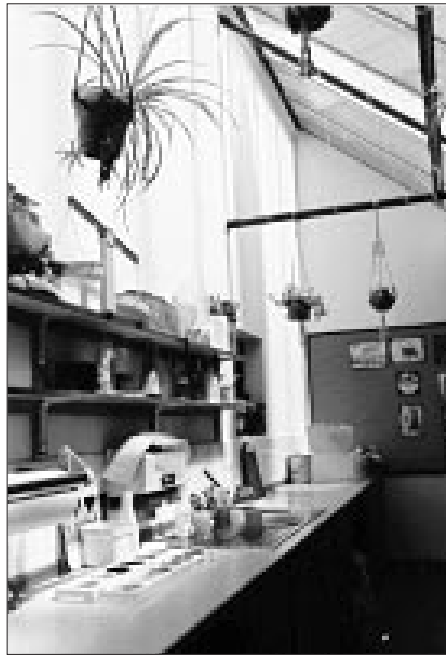
**South facing rooflights allow light and heat into the juniors' workspaces, but do not open and overheating can occur**

Classroom temperatures remained within a comfort range of 17 to 23°C for 88% of a one-year period, and temperatures over 27°C were recorded for only 9 hours over the whole school year. Better cross ventilation and avoidance of solar overheating could have been achieved by having opening rooflights and shading for them.

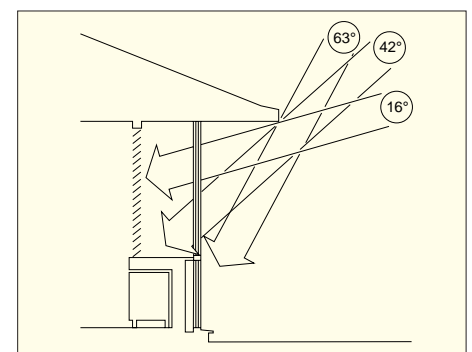
**The overhang shades high angle sun with backup from venetian blinds for lower angles in the mornings, afternoons and spring and autumn**

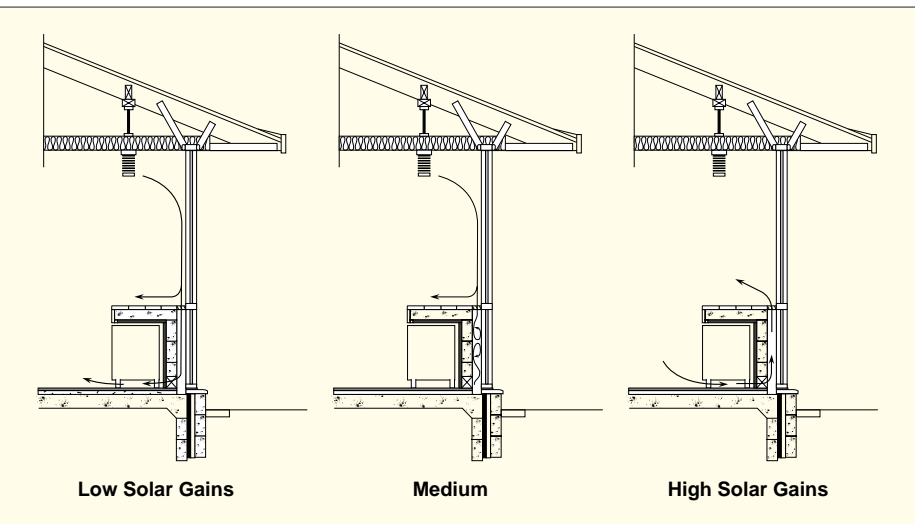
**Air flow from the Trombe wall occurred on sunny days, but on less sunny days modelling indicated that a cold down draught from the windows stopped the warm air rising out of the cavity. When a window was opened for ventilation, heat could be quickly flushed out of the cavity and several days of sun required to restore a positive thermal gradient in the cavity**

The Trombe bench contributed less to the building's performance than had been envisaged by the designer. Its relatively small area and limited mass meant that it accounted for only a small proportion of the total energy flow into each classroom – approximately 3% of the space heating energy.

Whilst warm air circulation could occur on sunny days, this could be easily disrupted by down draughts from the windows and by opening of the windows. During periods of low solar radiation down draughts could also cause a reverse flow with cool air flowing across classroom floors.

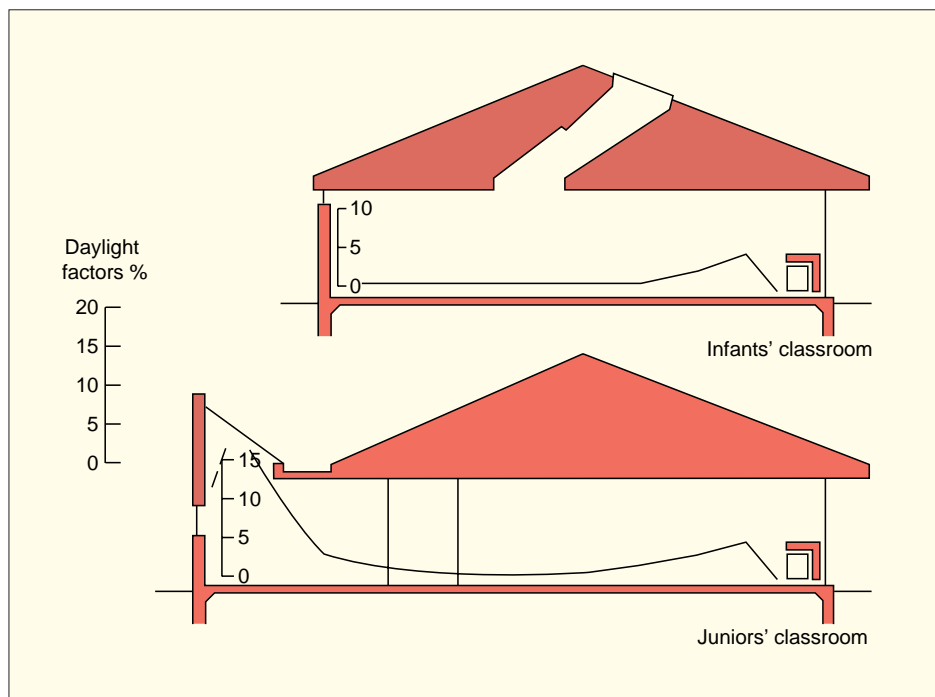
**Daylight factors:** the 750 mm roof overhang resulted in daylight levels rapidly decreasing to less than 2% within 4.5 metres from the window. The rooflights gave high light levels in the juniors' workspace but made little measurable difference to the infants' rooms

Whilst the large windows were appreciated for the views and sunshine, the 750 mm wide roof overhang did reduce the daylighting levels. Daylight factors dropped below 5% within the first metre of usable floor space and were around 2% for a large part of the room. Daylight was also reduced when the venetian blinds were down. As a result, the electric lighting was used for extensive periods.

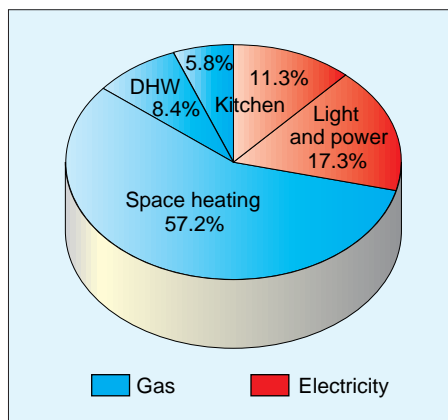
**The annual primary energy use for the school was 347 900 kWh/year**

During the year of monitoring, the heating demand occurred between the second weeks of October and May. Annual fuel use was 227 517 kWh delivered or 288 420 kWh primary energy (excluding kitchen use of 59 480 kWh primary).

Delivered		Primary	
	kWh/m <sup>2</sup>	%	kWh/m <sup>2</sup>	%
Space heating	134.1	81	144.8	69
Water heating	19.8	12	21.4	10
Light and power	11.7	7	43.7	21
Total	165.6		209.9

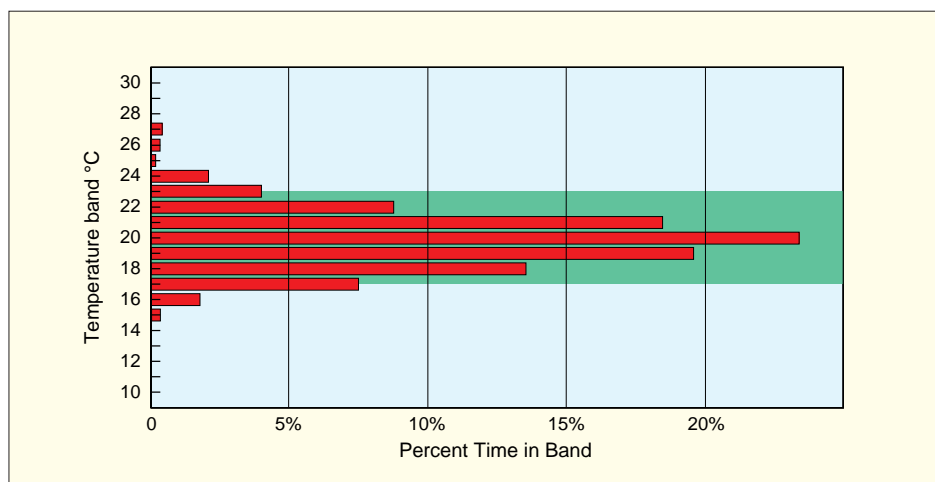
**Classroom temperatures were reasonable for most of the time. Any complaints of overheating seemed to stem from low angle morning or afternoon sunshine falling directly on teachers**

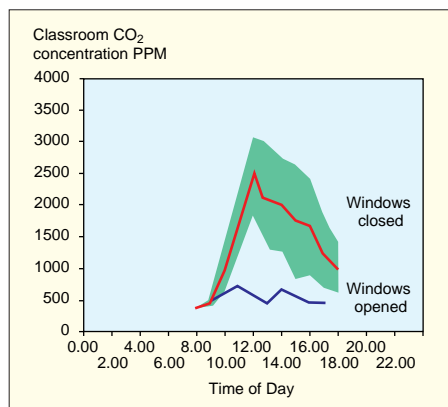
**Night-time air changes were low at 0.2 to 0.4 and average daytime ones varied between 1 and 2 with the windows closed which resulted in stuffiness. Window opening had a great effect on CO<sub>2</sub> levels but resulted in draughts because of the window design**

The decision to reduce heat losses by minimising infiltration rates but also to use an inflexible window design, resulted in poor air quality in the school. Teachers experienced problems with odour and stuffiness which could only be cleared by opening the large south facing windows. However, the resultant draughts, caused by the strong winds on the exposed site, disturbed teaching material on or adjacent to the Trombe benches. Therefore staff were reluctant to open the windows and consequently natural ventilation rates of 1 to 2 ach were below the 2.5 ach needed to meet Department for Education and Employment (DfEE) standards. Moreover, infiltration levels measured overnight were found to be very low at only 0.2 to 0.4 ach. It was therefore not surprising that CO<sub>2</sub> levels were averaging over 1200 ppm with a peak above 3000 ppm. A recommended level would be around 800 ppm.

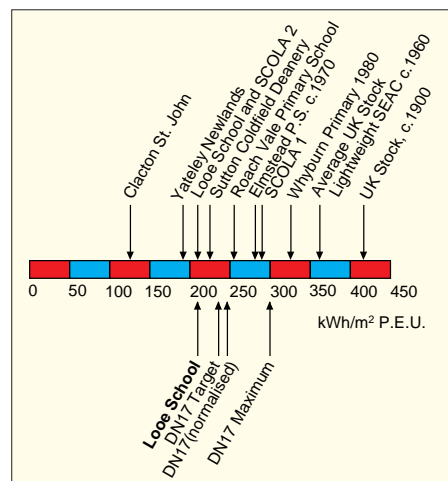
**Annual primary energy use in schools: Looe's 210 kWh/m<sup>2</sup> put it in front of other low energy schools**

To convert metered fuel into primary energy, conversion factors of 3.73 for electric energy and 1.08 for gas energy were used. These correspond to the approximate generation and transmission losses involved in these fuels.

The school's figure of 210 kWh/m<sup>2</sup> compares very favourably with the DfEE Design Note 17 primary energy target of 247 kWh/m<sup>2</sup> for the same conditions. Part of the explanation for the low energy use is that solar gains shortened the heating season at both ends. There was a good correlation between solar radiation and heating energy use, with the major solar contribution coming from direct solar gain through the south facing windows and rooflights. The solar contribution (1778 kWh/week) to the gross total amount of energy needed to heat the school (6838 kWh/week) was 26%.

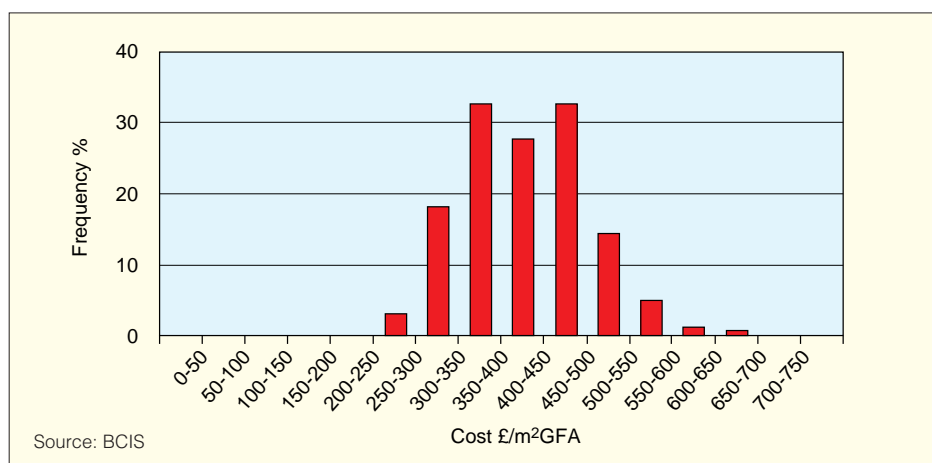
**Primary school costs: Looe at £417/m<sup>2</sup> cost no more than the average school**

The capital cost of Looe School, normalised to the second quarter of 1986, was £417/m<sup>2</sup>. In comparison with other primary school construction costs, this is an average cost.
